### TEST REPORT No

**6649-ZLK/2021**

#### IP68 tests of object:

**FT-700 LED lamp, FT-146 LED lamp, 2-pin Fristom connector**

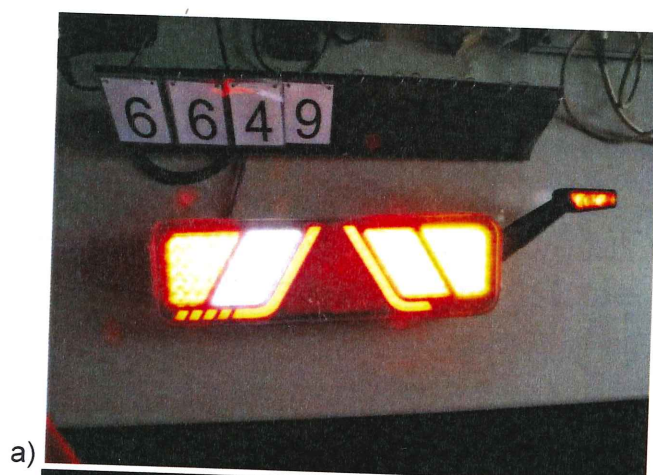
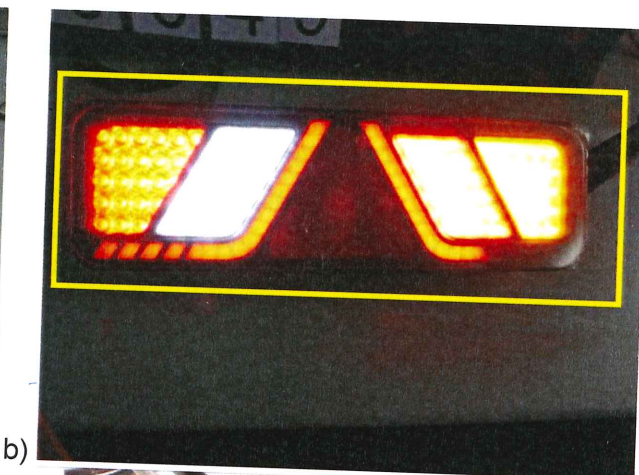
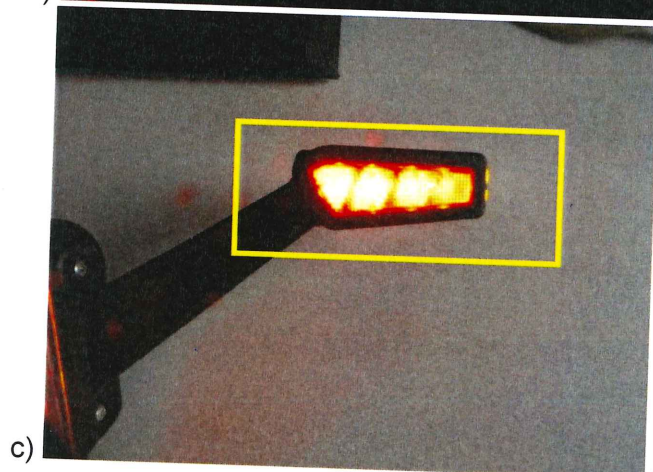
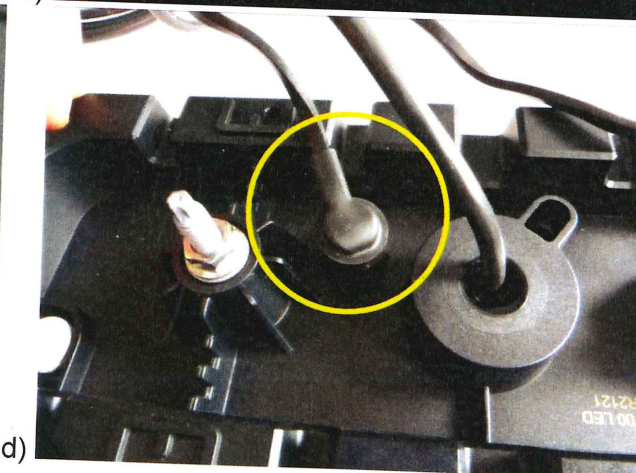
Photo. 1. a) General view of FT-700-146 LED, EUT, b) EUT 6649.01, c) EUT 6649.02, d) EUT 6649.03

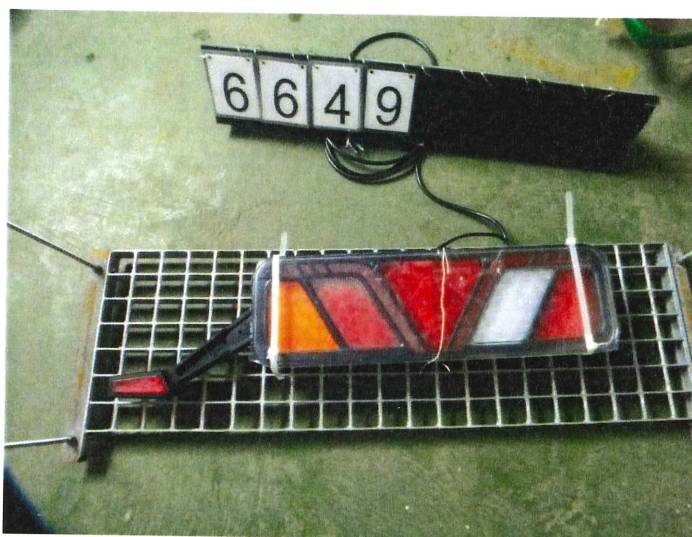
Photo. 2. EUT mounted on support before IPX8 test

Before the test, the sample was mounted on the support (as shown in photography 2) and immersed in water for time 3 h (as shown in photography 3). All EUTs were tested simultaneously. After 180 min of immersion were performed:

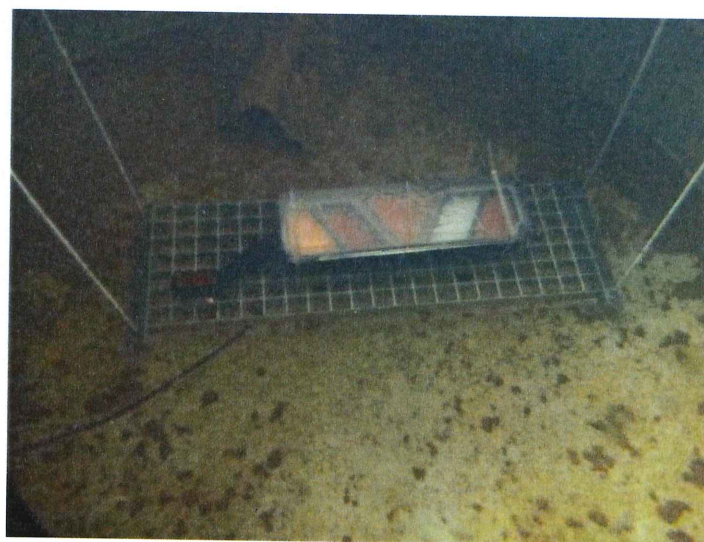
Photo. 3. EUT immersed in water

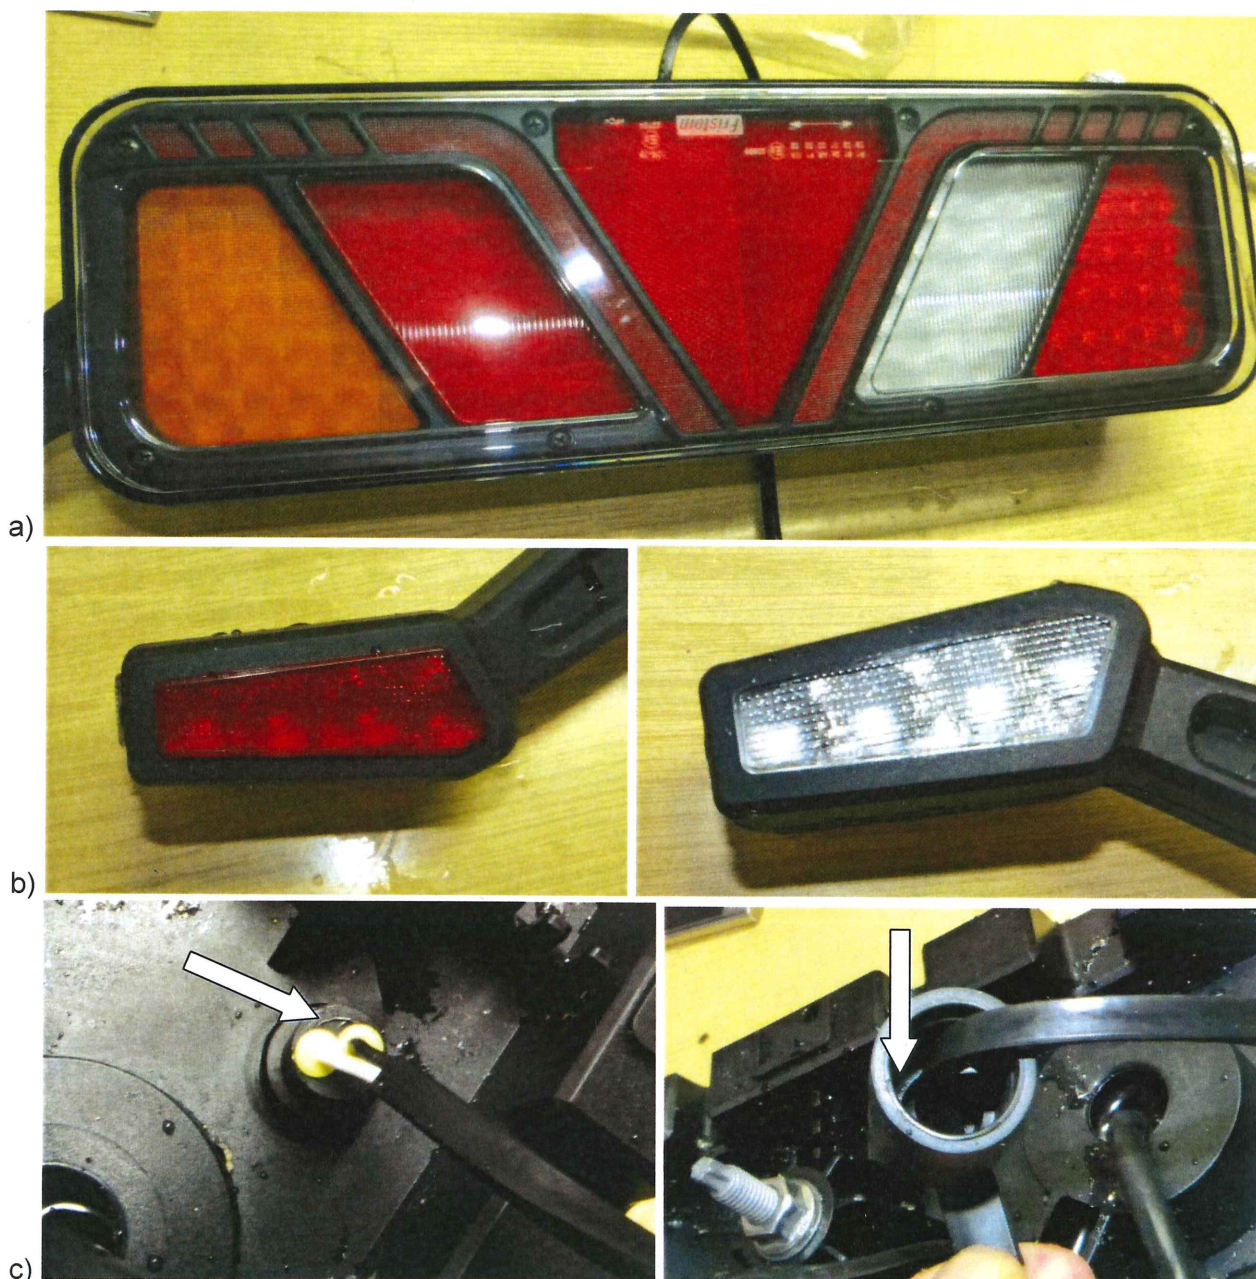
- During visual inspection no water inside objects 6649.01 and 6649.02 was found (as shown in photo. 4a and 4b),
- A small amount of water drops was found under the cover of EUT 6649.03 (as shown in photo. 4c). Water probably got there during removing the rubber cover of connector.
- Functional test result was positive (as shown in photo. 5),
- HV test result was positive, no breakdown of insulation occurred.

Photo. 4. Visual inspection after IPX8 test

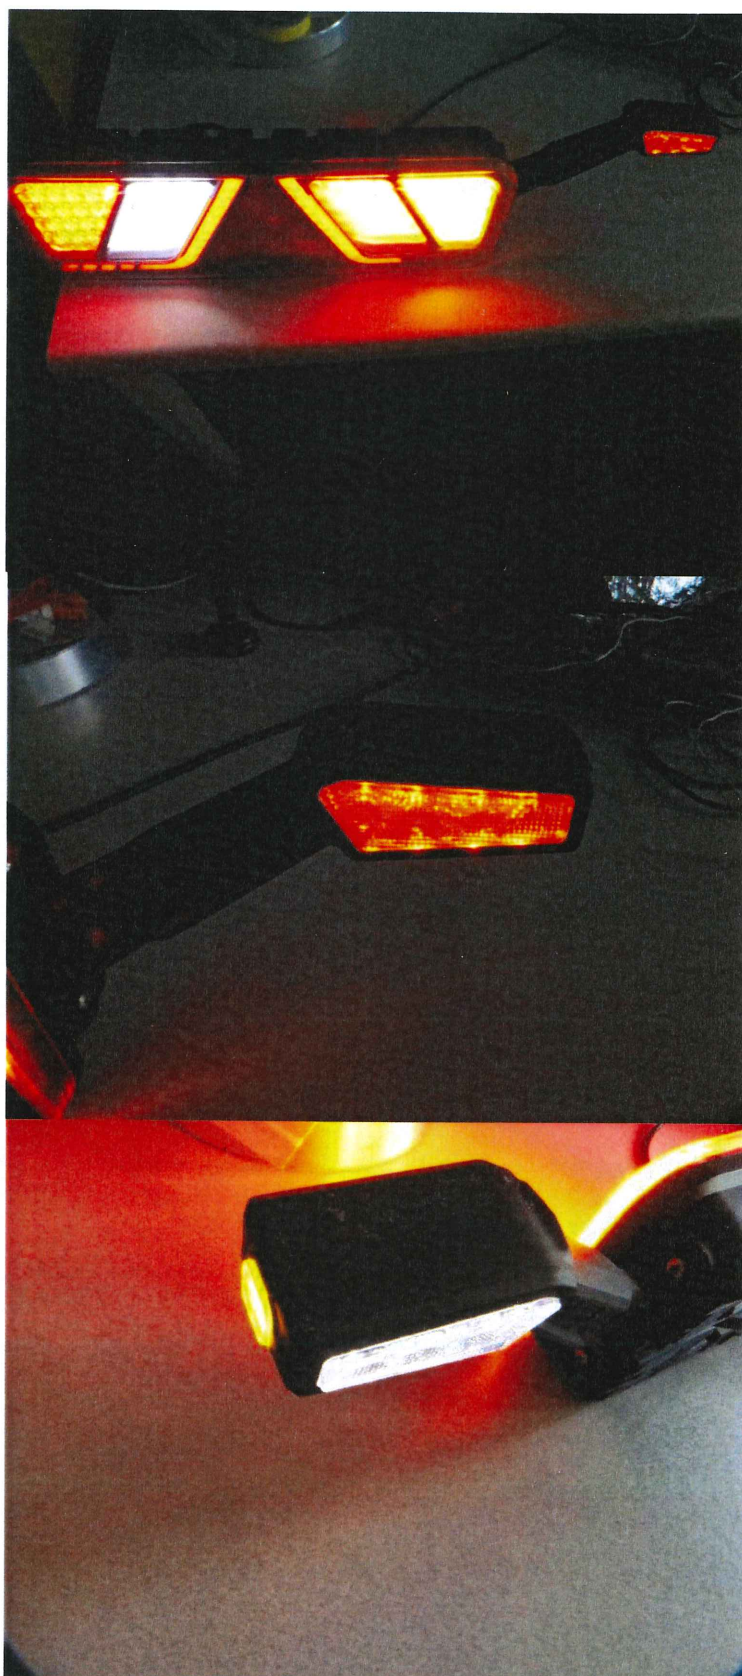
Photo. 5. Functional test after IPX8 test

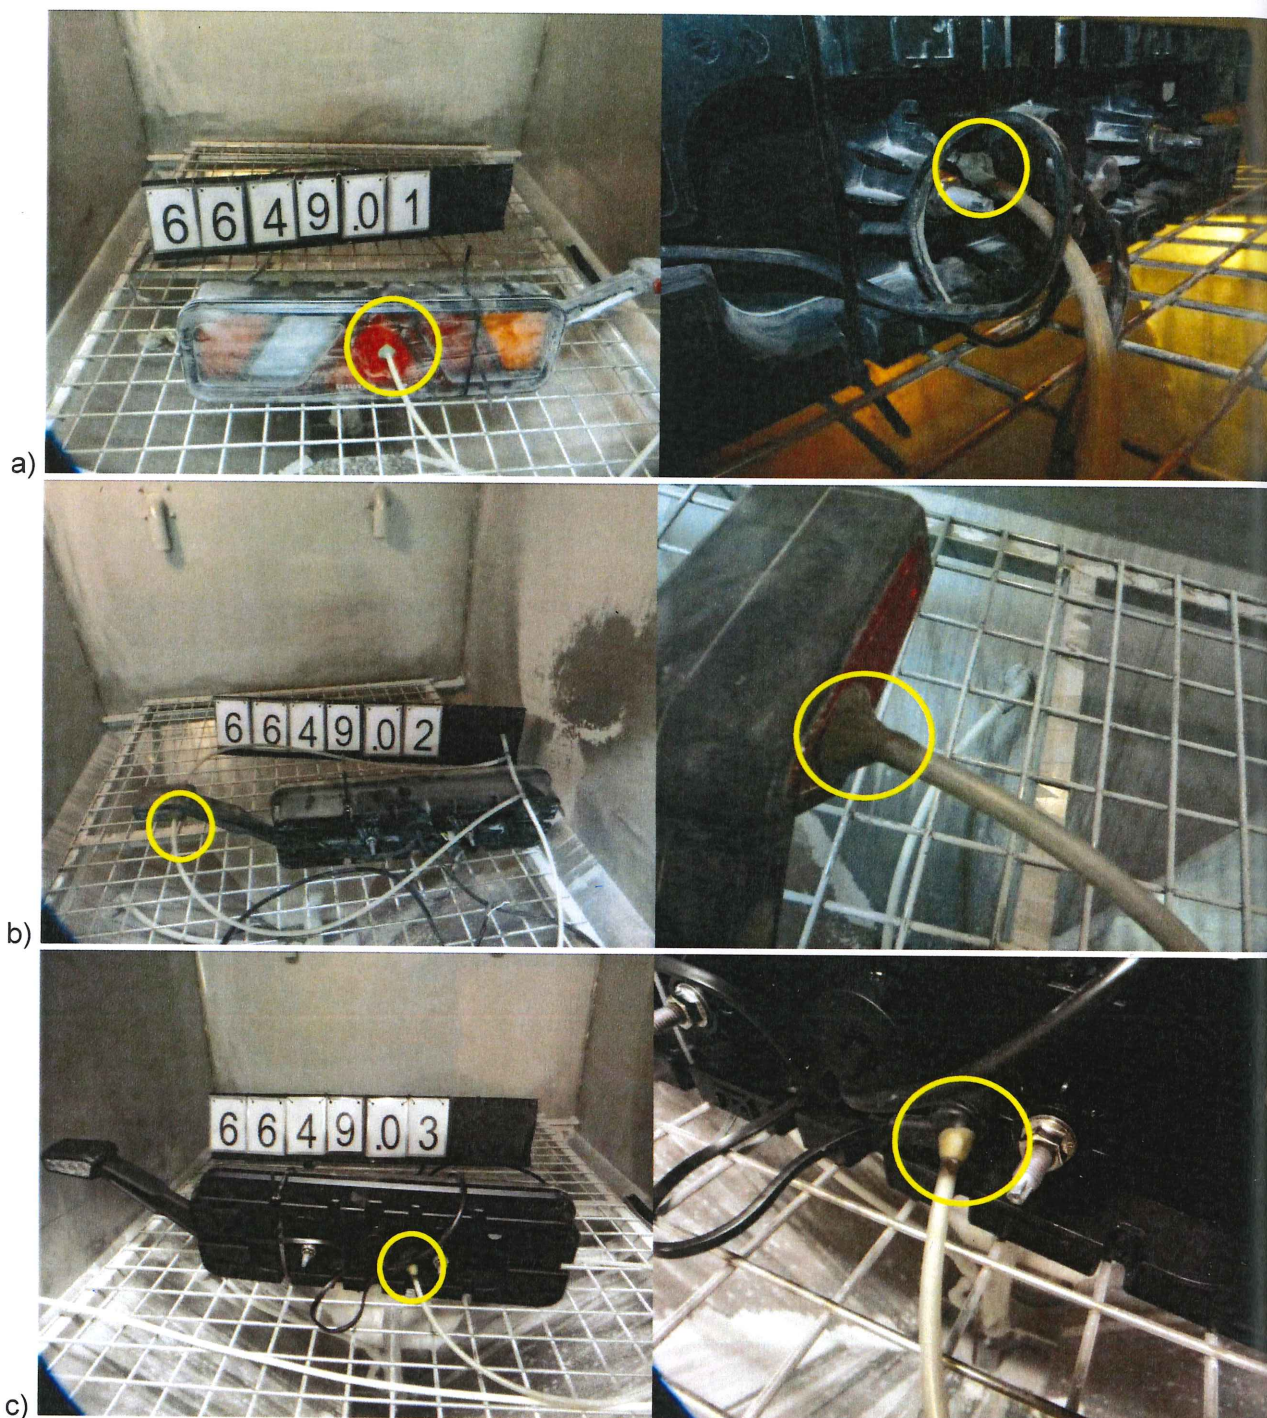
Before the test, the sample was placed in the dust chamber and connected to a vacuum generating system as shown in photo. 6. Places, where vacuum generating system was connected to EUT is marked.

Photo. 6. EUT before IP6X test

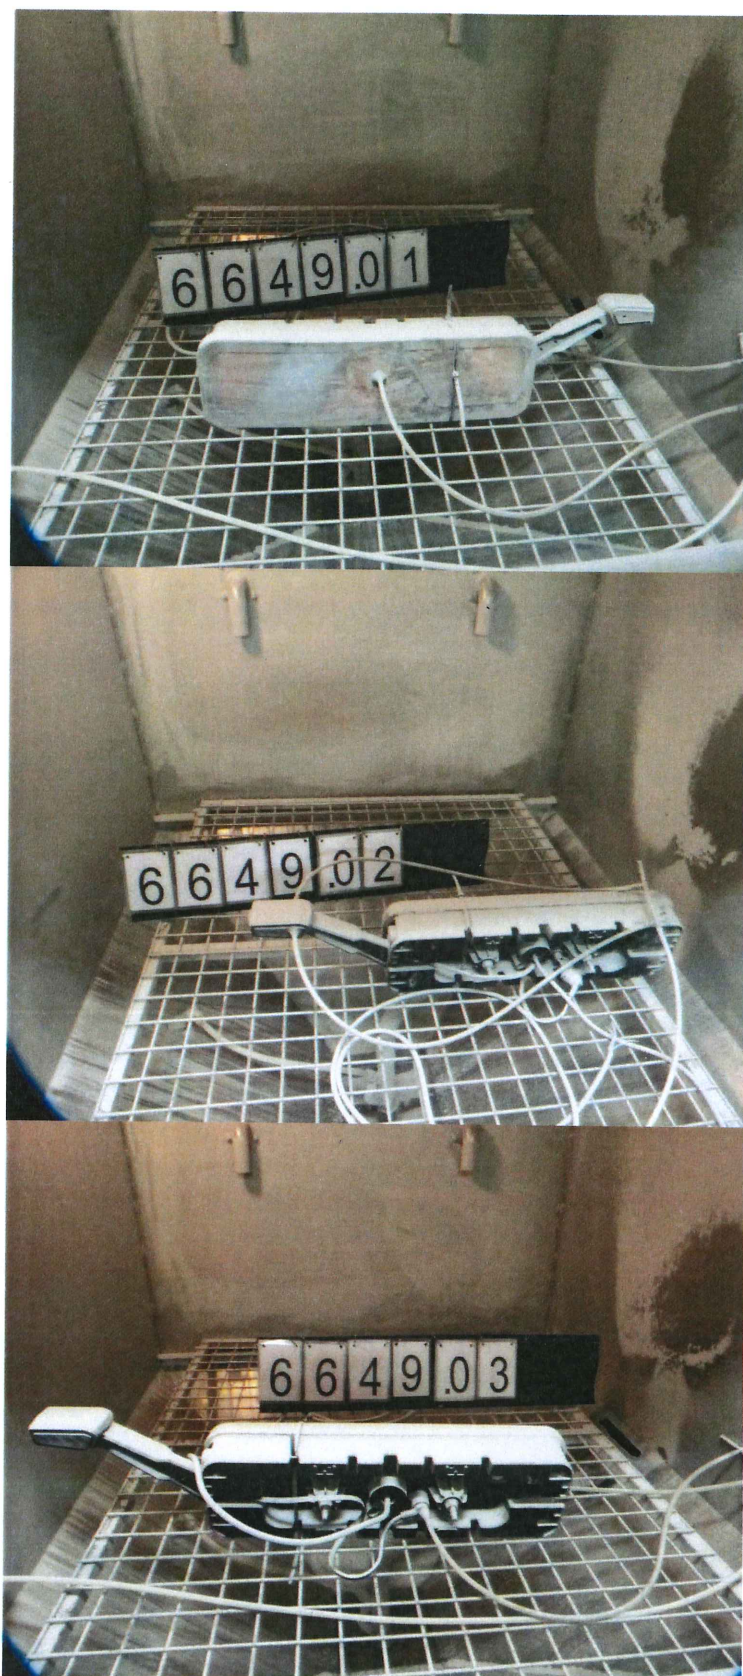
Photo. 7. EUT after IP6X test

Photo. 7 shows EUTs after test.

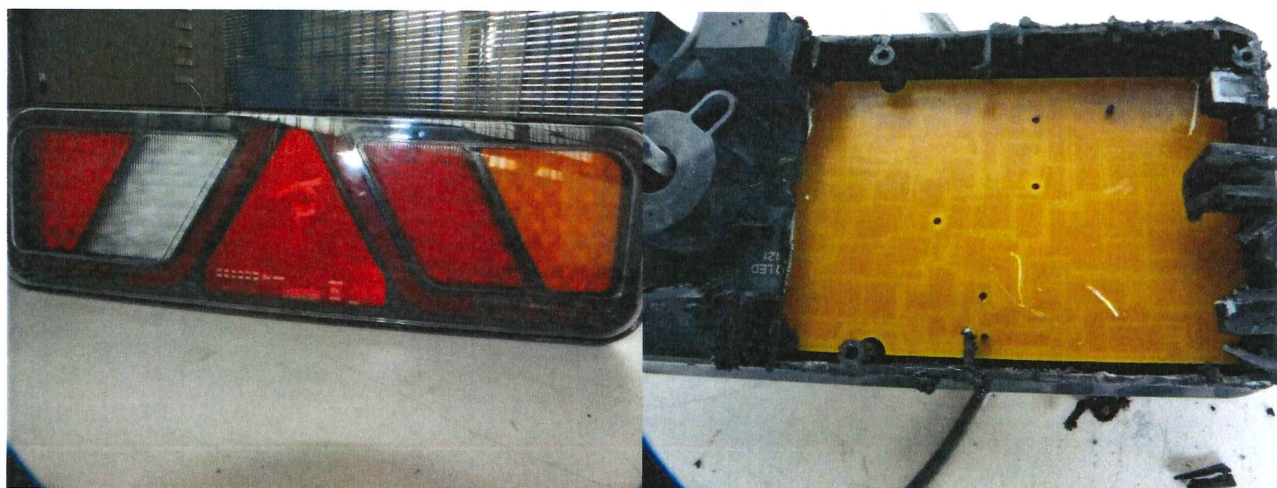
No signs of dust penetration into the housing were found.

Photo. 8. Inspection of EUT 6649.01 after IP6X test

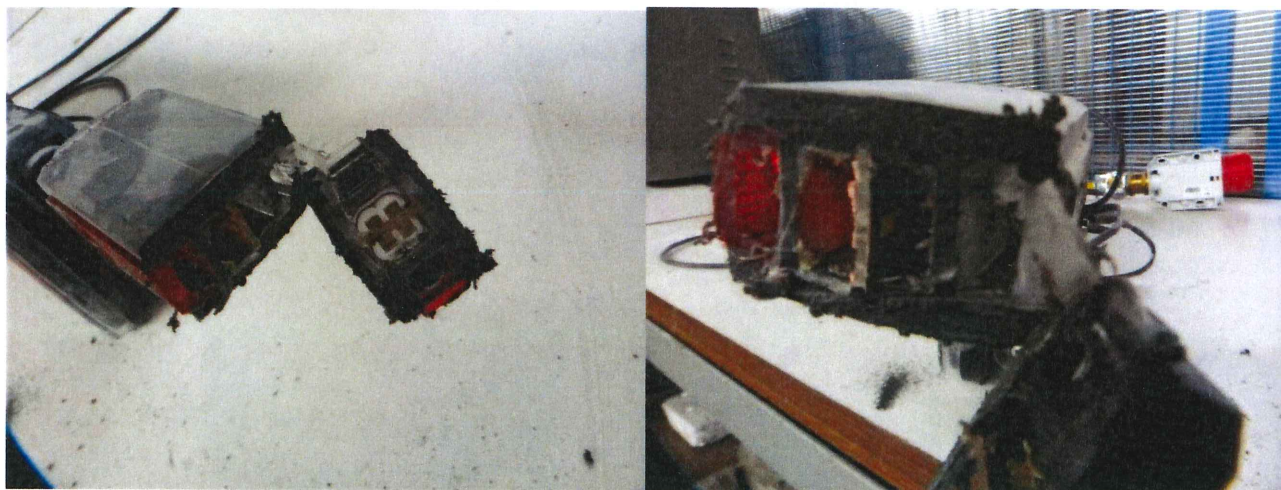
Photo. 9. Inspection of EUT 6649.02 after IP6X test

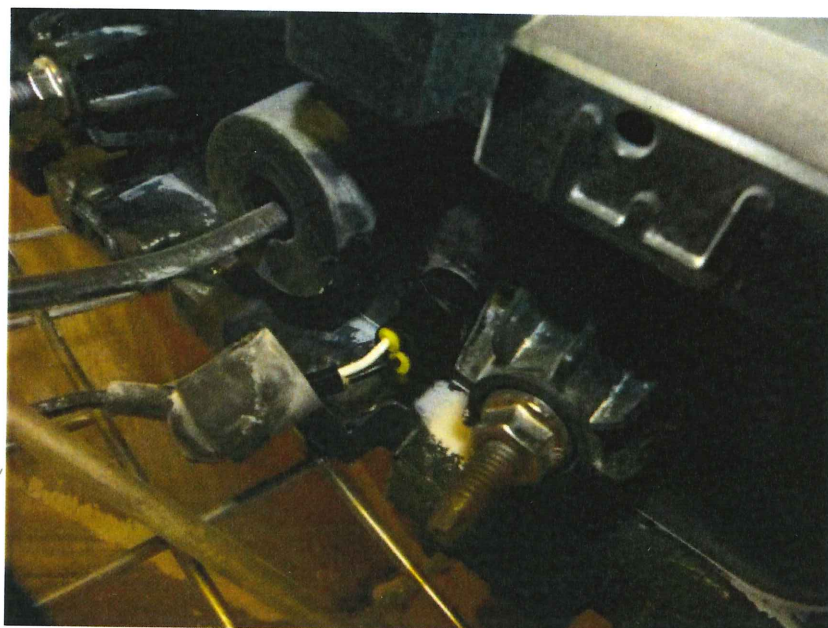
Photo. 10. Inspection of EUT 6649.03 after IP6X test
